UNITED STATES ARMY AVIATION BOARD Fort Rucker, Alabama

REPORT OF TEST

PROJECT NR AVN 2260

HELICOPTER-MOUNTED SS-11 ANTI-TANK GUIDED MISSILE SYSTEM

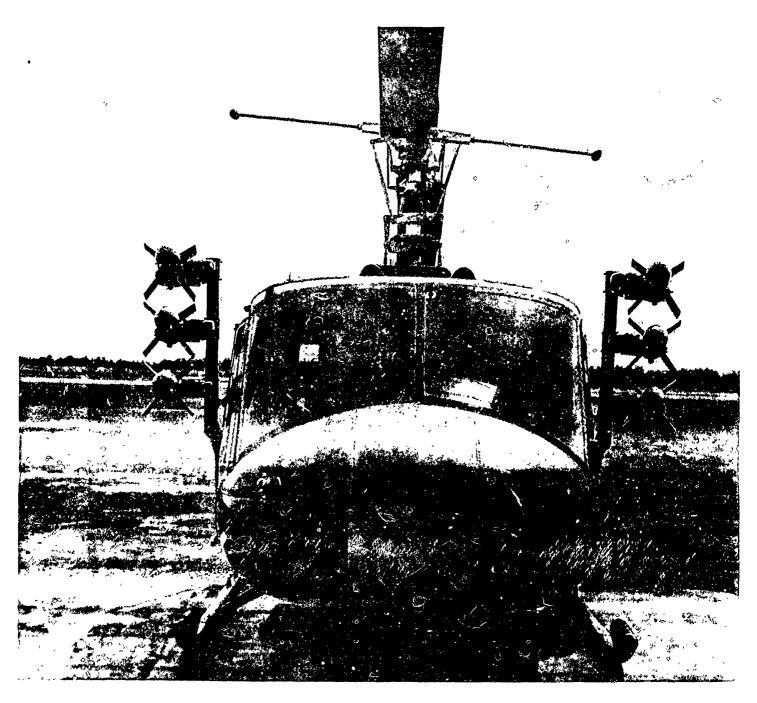
Figure 2. Launcher booms in the stowed position

- booms) were installed on the helicopter. The launchers can be jettisoned from the helicopter individually or simultaneously in an emergency. The launcher booms can be readily removed or folded vertically to the stowed position (see figure 2).

- c. With outboard missiles in place, the installation extended 4 feet 10 inches from the sides of the fuselage, and was easily stowed vertically by removing four bolts. With missiles installed on the launchers, minimum ground clearance was one foot six inches. Maintenance missiles (numbers 5 and 6) cleared the fuselage by 112 inches.

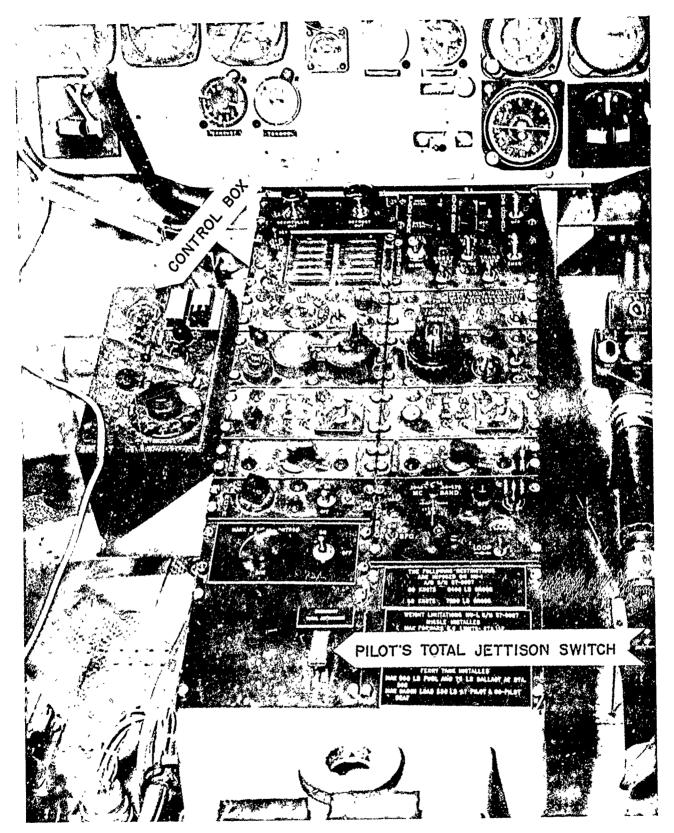
Figure 3. Location of the control box and the pilot's "Total" jettison switch

- b. The gumner's controls were installed on the copilot's side of the cockpit without removing the flight controls. The control box was mounted on the pedestal between the pilot's and copilot's seats in a position convenient to the gumner (see figure 3). Items on this control box were:

2. The signal generator and the selection box were installed in the cabin just aft of the pedestal between the two pilots. These two items were not manipulated by the gunner and should have been installed out of the way.

Install the signal generator and the selection box in one of the aft electrical or accessory compartments.

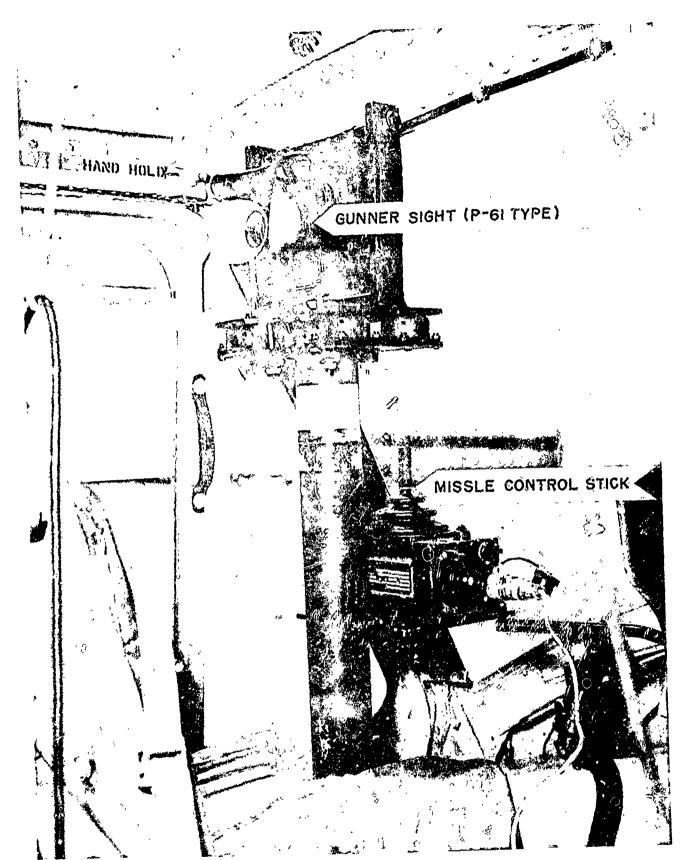
Figure 4. Gunner's sight and missile control stick

- c. The gumner's missile control stick and the sight were located on a pole mounted on the front of his teat (see figure 4). The sight used was one developed by the University of Rochester for the P-61 "Black Widow" night fighter. It consisted of eight-power binoculars mounted in a frame and isolat 1 from the helicopter vibrations in the horizontal plane by two dampers which employed a rubber diaphragm in a thin cylinder. Vertical vibrations induced to the sight by the helicopter were reduced to an acceptable level by mounting the sight on four vibration dampers. The mount for the sight and the control stick was fabricated and installed at the Aviation Board. A standard Mark 8 aircraft gunsight was installed on the pilot's side (see figure 5). The pilot's sight and the gumner's binoculars were aligned to enable the pilot to keep the target in the gumner's binoculars.

- 2. Yawing movements of the halicopter caused the gunner to lose the target and missile in the sight and miss the target.
- 3. The mounting for the P-61 sight and missile control stick fabricated at the Aviation Board was satisfactory functionally but was cumbersome and a potential hazard to the gunner if a crash occurred.

Mount the P-61 sight overhead in the HU-1 installation in such a manner that it can be telescoped down before the gunner for firing and stowed when not in use. The mounting should be adjustable in the three axes and should provide vibration damping adequate to eliminate or substantially reduce the effects of helicopter vibrations. Mount the missile control stick on a small support which could be quickly inserted in a bracket on the front of the gunner's seat for firing and stowed near the gunner when not in use.

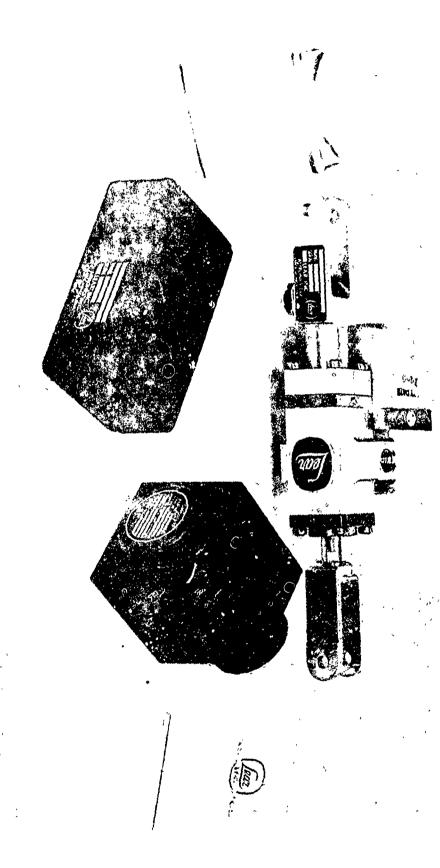
Figure 6. Components of the Lear MIIACON DEC (automatic heading control)

- d. A heading control system for the helicopter, (see figure 6) designated as the lear Millimin Automatic Control and Damper Heading Command (Lear MIIACON DHC), was manufactured by Lear, Inc., for this test. Item was comprised of components in production and designed to military specifications. The system weighed approximately four pounds. Two switches were provided on the cyclic stick for pilot operation of the system. John sighting the target in his sight the pilot would throw the engage switch to the ON position. This locked the helicopter on the heading to the target. By means of the two-way rate trim, the pilot was able to command small heading changes to correct for crosswinds on the firing run without disengaging the heading lock. This feature also enabled the pilot to track moving targets smoothly. The two operating switches were installed on the pilot's cyclic control stick (see figure 5) so that he could engage, operate, and disengage the heading control without diverting his attention from the target.

- (3) Testing with the heading control system (Lear MIIACON DHC) began with service-test firing number 11 (see chart in appendix C). Initial test firings utilizing the Lear MIIACON DHC indicated several modifications were necessary to give the equipment more positive control. The changes were made as testing continued and, by service-test firing number 25, the equipment was functioning as desired. Subsequent to firing number 25, 17 missiles were fired of which 15 were hits, resulting in an accuracy figure of 89 percent. This high percentage of hits was a direct result of the positive heading control provided by the Lear MIIACON DHC.

Adopt the Lear MIIACON DHC, evaluated during this test, as a necessary component of the helicoptermounted SS-11 system.
